BUILDING SURVEY REPORT

PROPERTY Sample Survey
Anytown
AA11 1AA

SURVEY DATE 2 Jan 2018

REF 12345

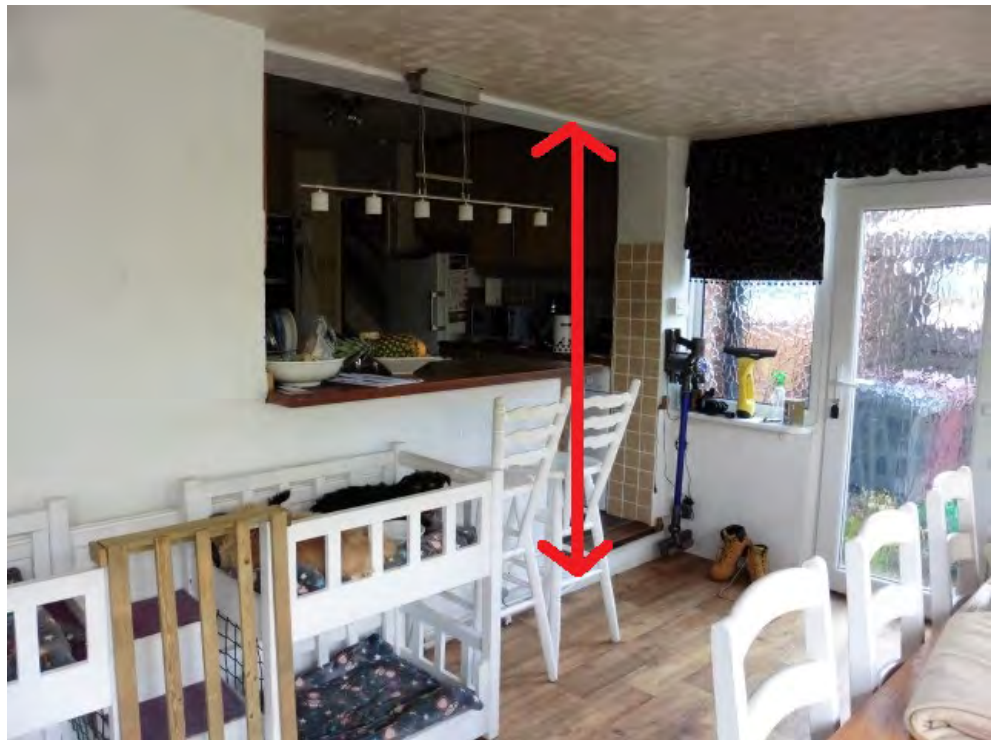
Wall partially removed between the kitchen and sun room

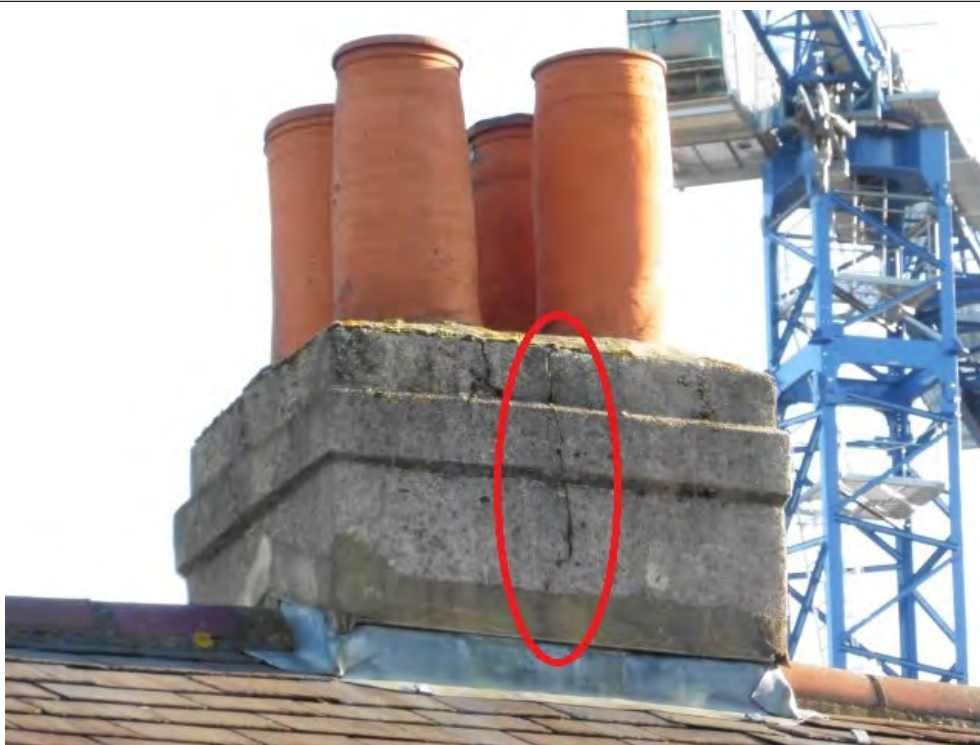
Central stack viewed from the front

Action Required	<p>The chimney stacks should be regularly monitored for any indications of damage, instability or other defects. You should carry out a thorough visual inspection at least once a year, ideally in the Spring, and ideally at roof level, to identify and repair any damage that could have been caused by winter weather. Missing, loose or defective mortar should be repointed as necessary. It is advisable to fit cowls on the top of the pots of any open flues.</p>

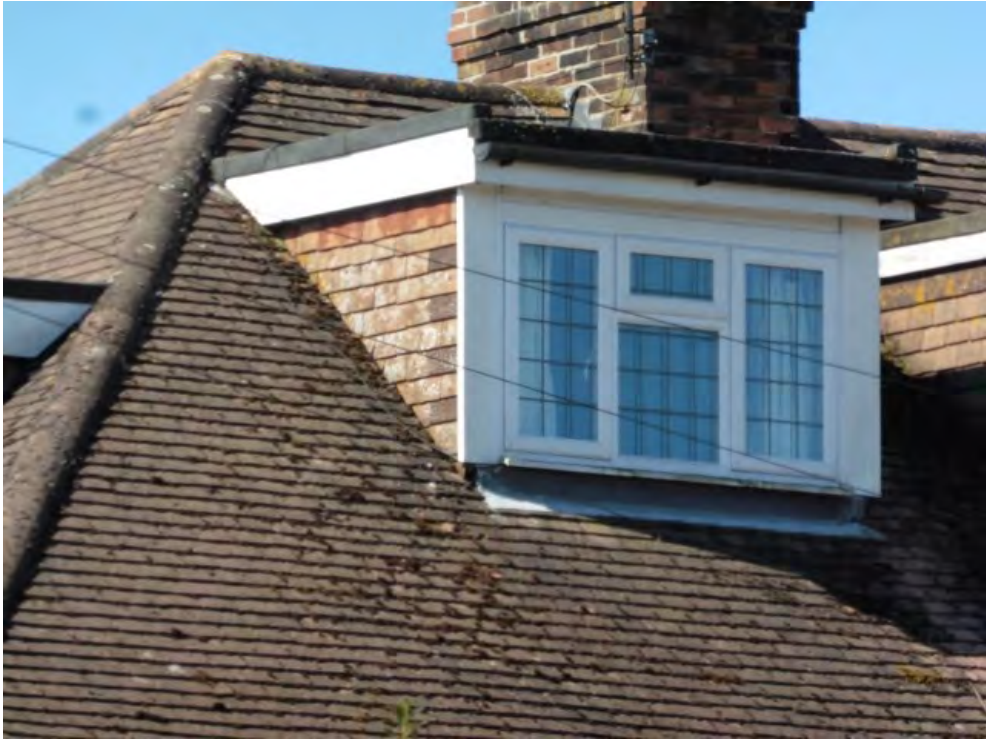
4.2 Roof Coverings	Condition rating	1
Construction & Type	<p>The roof is formed from a single ridge running across the width of the property, with pitches to the front and rear and with a hip to the left side. The main roof pitches are covered with interlocking concrete tiles. The roofs of the front and rear dormers and the sun room extension are flat and covered with bituminised (also known as “torched”) felt.</p>		
Nature of inspection and Limitations	<p>The roof was examined from ground level with the aid of binoculars where necessary for possible defects including sagging, collapse, broken/missing/damaged tiles, holes, and other evidence of failure.</p>		
Condition	<p>No significant defects were noted and the main roof was found to be structurally stable. No evidence was seen of unusual sagging or other movement which might indicate that the structure is failing. No evidence was seen of any unusual amounts of moss growth, or of slipped, chipped or cracked tiles.</p>

<p>Front roof and dormer</p> </div>

Action Required	<p>Carry out normal maintenance including removal of moss build-up. Any slipped, missing or broken tiles on the roof pitches should be repaired and replaced. You should carry out a thorough visual inspection at least once a year, ideally in the Spring to identify and repair any damage that could have been caused by winter weather.</p>		
	<div style="text-align: center;">

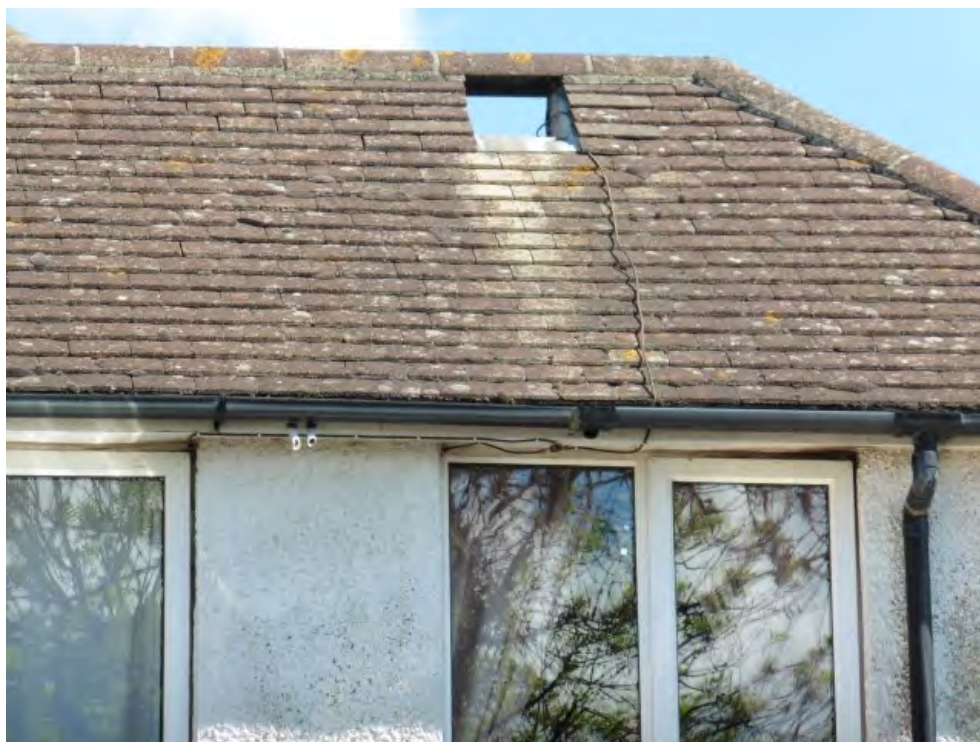
Rear roof pitch

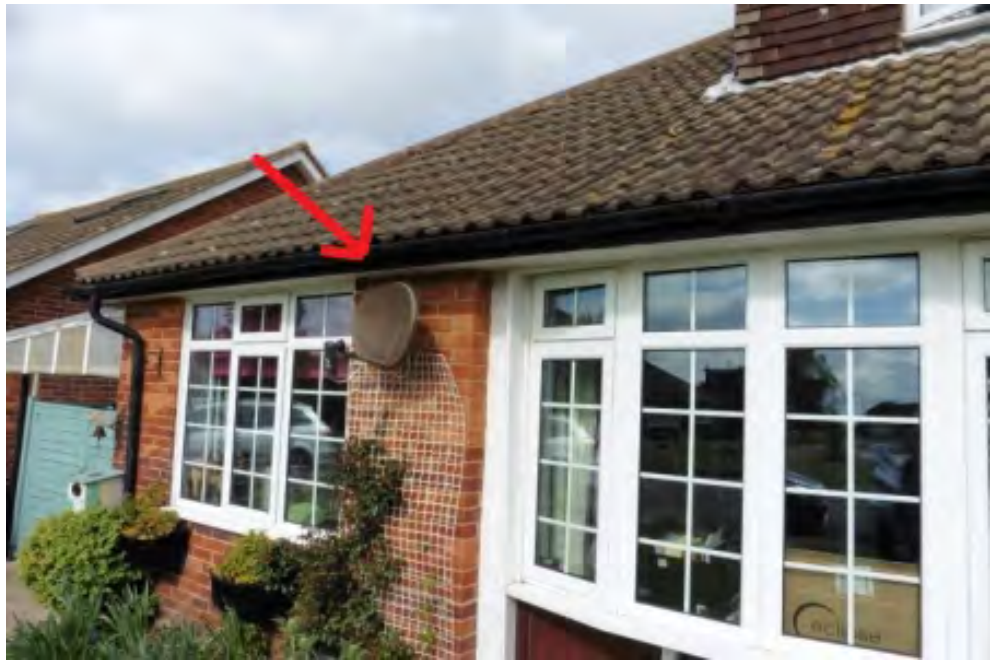
<h3>4.3 Rainwater and Above Ground Drainage Fittings</h3>	Condition rating	2
Construction & Type	<p>The rainwater gutters and downpipes are plastic. Gullies and downpipes for rainwater are provided around the property and these drain to ground soakaways or into the mains drainage system.</p>		
Nature of inspection and Limitations	<p>An inspection was carried out from ground level with the aid of binoculars where necessary to look for possible areas of leakage, misalignment, overflow and other defects.</p> <p>As it was dry at the time of survey no assessment could be made as to the effectiveness of the rainwater fittings.</p>		
Condition	<p>No significant defects were noted. No evidence was seen of excessive staining of the walls or adjacent areas, which might indicate that significant leaks have been occurring.</p> <p>However, it was noted that the gutter at the front is sagging slightly in the area above the satellite dish, which may mean that it leaks.</p> <p>From a purely visual inspection it is impossible to determine whether water from the gutters and downpipes is directed into the mains drains or into soakaways as all of these elements would be under the ground in any case.</p>

Sagging gutter at the front

Action Required	<p>The gutter at the front should be repositioned to ensure that it is not sagging or leaking. This is not considered to be work of an urgent or major nature, but should be carried out as soon as possible to prevent further damage to the building.</p> <p>Gutters and downpipes should be cleaned and inspected</p>

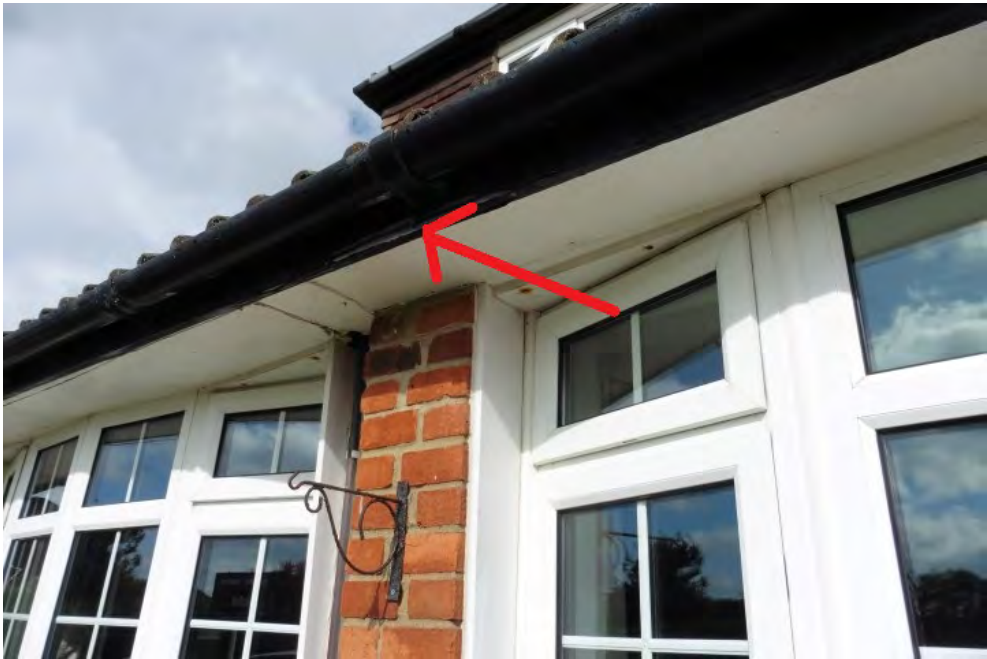
<h2 style="margin: 0;">4.6 External Joinery and Finishes</h2>	Condition rating	3
Construction & Type	<p>This includes such items as woodwork at the roof edges, trim panels and any timber porch/canopy. Soffits are the horizontal timbers joining the fascia boards to the house walls. Fascia boards are the vertical timbers to which the gutters are normally fixed. Barge boards are the diagonal boards at the roof edge on the gable end of the house.</p>		
Nature of inspection and Limitations	<p>All such materials were examined from ground level and with the aid of binoculars from vantage points within the grounds of the property and suitable public areas around. Decorations were examined for indications of poor maintenance, rot and other defects.</p>		
Condition	<p>Widespread evidence was found of rot in the external joinery, including both the fascias at the front and the soffits at the back. The timber is failing and what we have spread to other parts of the building.</p>

<p style="margin-top: 10px;">Rot in the fascia at the front</p> </div>

Action Required	<p>Urgent repairs are required to replace rotten timbers around the edges of the roof. Although some areas of rot were identified, others may be present, and it is possible that the ends of the roof rafters may have been affected. A thorough investigation should be carried out to identify all rotten timber, which should be cut out and replaced. This work is considered to be of an urgent nature and should be carried out immediately upon occupation of the property.</p>		
	<div style="text-align: center;">

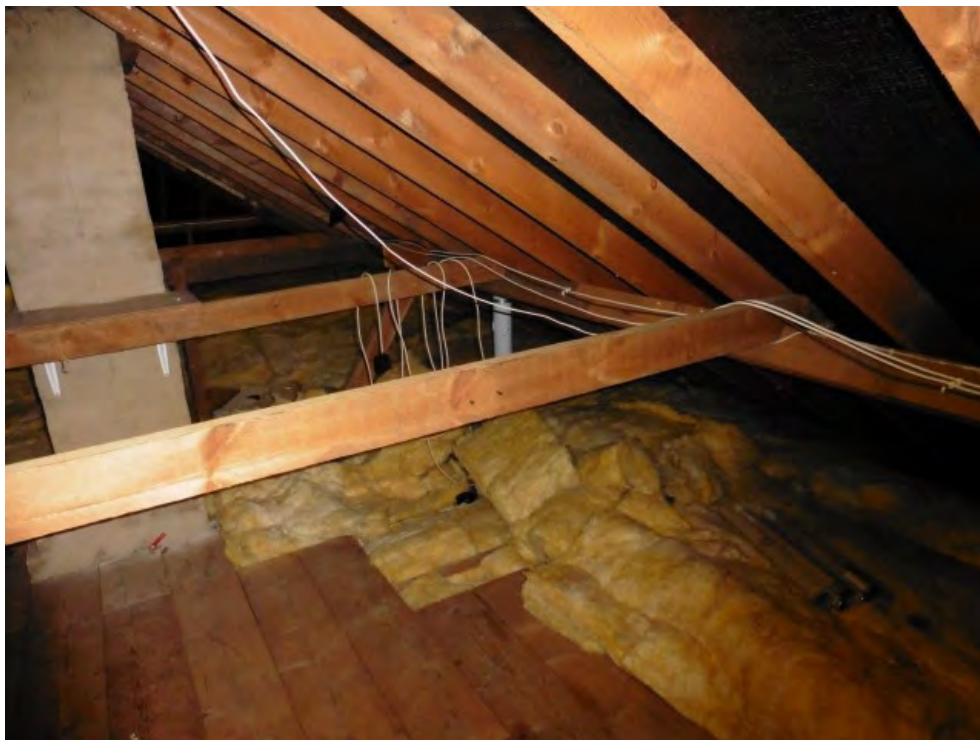
Looking towards the right

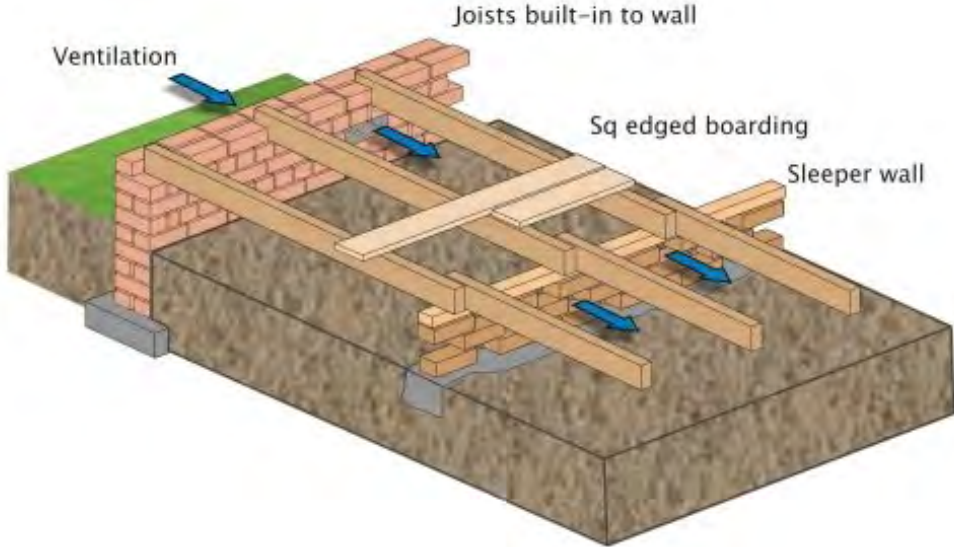
<h2 style="margin: 0;">5.4 Floors</h2>	<p style="text-align: center;">Condition rating</p>	<p style="margin: 0;">3</p>
<p>Construction & Type</p>	<p>The floors on both ground and first floors are of suspended timber construction, except for the sun room extension which has a solid concrete floor.</p>		
<p>Nature of inspection and Limitations</p>	<p>Floors were examined for sagging, hogging, unevenness, undue springiness and other signs of failure or damage. Fixed floor coverings in most rooms prevented direct examination of the floor surfaces.</p>		
<p>Condition</p>	<p>Floors on the ground floor were found to be unusually springy and bouncy when walked upon. This can often indicate that the substructure of the floor has become affected by rot or other timber defects, often as a result of a lack of ventilation of the subfloor void. Although it was not possible to gain access to the space beneath the floors, it is anticipated that timbers will be found to have become weakened and possibly broken.</p>

<p style="margin-top: 10px;">Suspended timber floor construction</p> </div>

<p>Action Required</p>	<p>Further investigations are required to explore the sub floor void, particularly in the living room, as the unusual springiness of the floors suggests that some significant timber defects are present. This will require the floor coverings to be lifted and floorboards released. It is thought likely that the supporting timbers joists will require replacement. These works are of a disruptive and major nature and should be carried out immediately upon occupation of the property.</p>		
	<div style="text-align: center;">

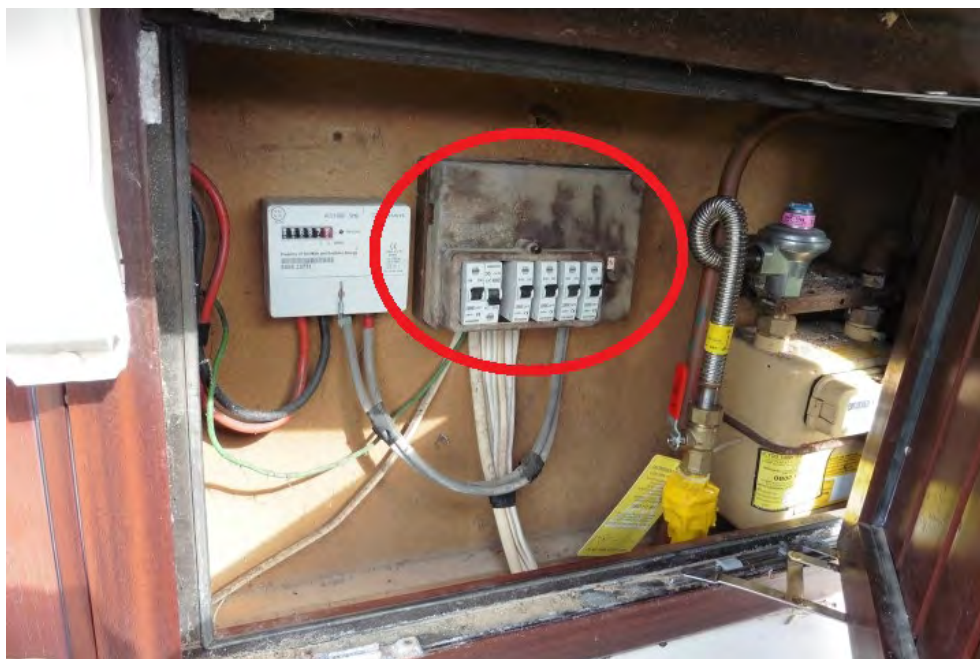
Fuse board

Condition	<p>The fuse board is of an older type without the more modern RCD protection devices installed, suggesting that it has not been upgraded recently. It must be assumed, therefore, that much of the installation dates from the 1970s or before and is, therefore, out of date. Although it was impossible to see most of the sockets in the rooms around the house, extension leads suggests that there are insufficient outlets for modern purposes. Power supplies to the sheds within the garden are, clearly, of an amateur nature and unlikely to meet reasonable safety standards. These supplies were noted to be of non-armoured cable.</p>		
Action Required	<p>The NICEIC recommends that electrical installations are subjected to an Electrical Installation Condition Report (EICR) by a competent person at least every</p>

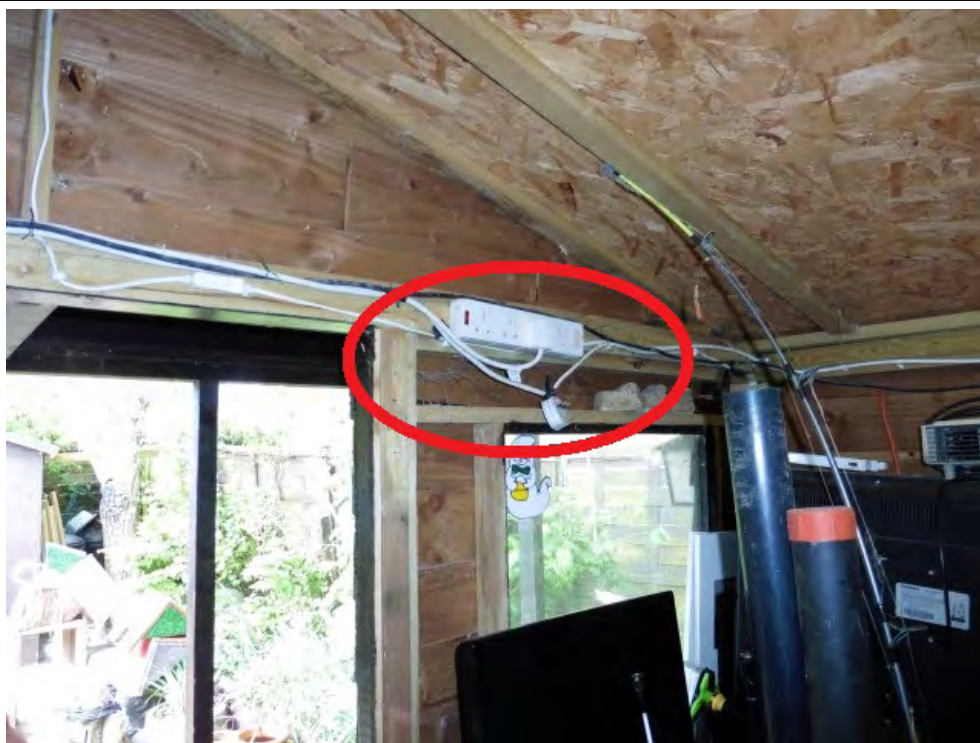
Poorly managed wiring in shed 4

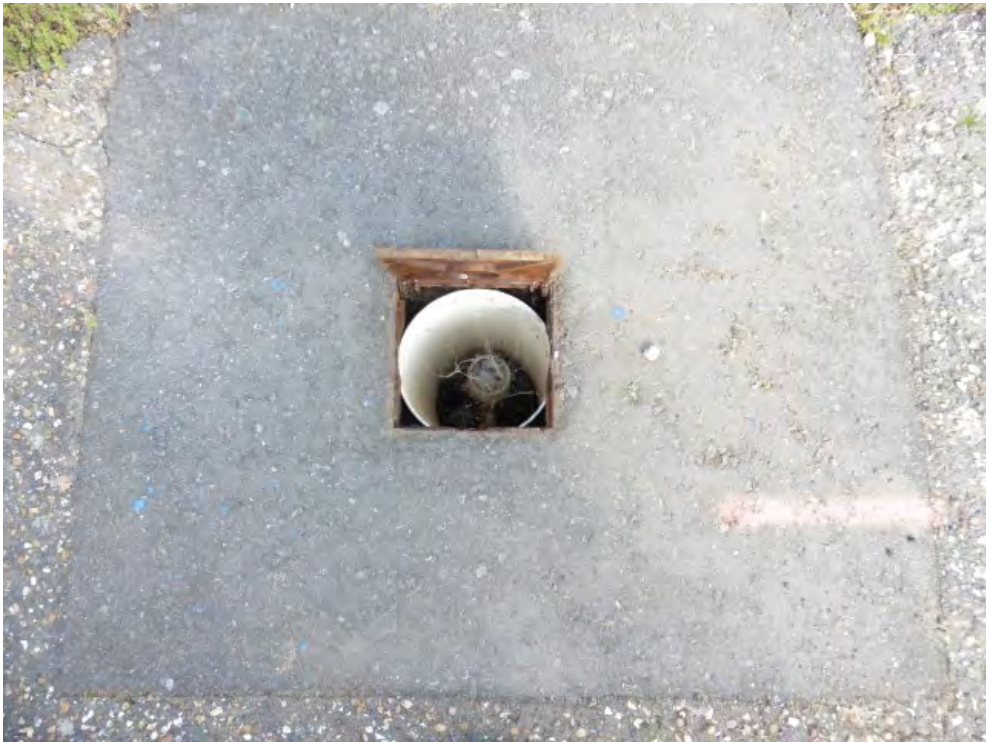
</div> <p style="text-align: center;">Location of water meter</p>

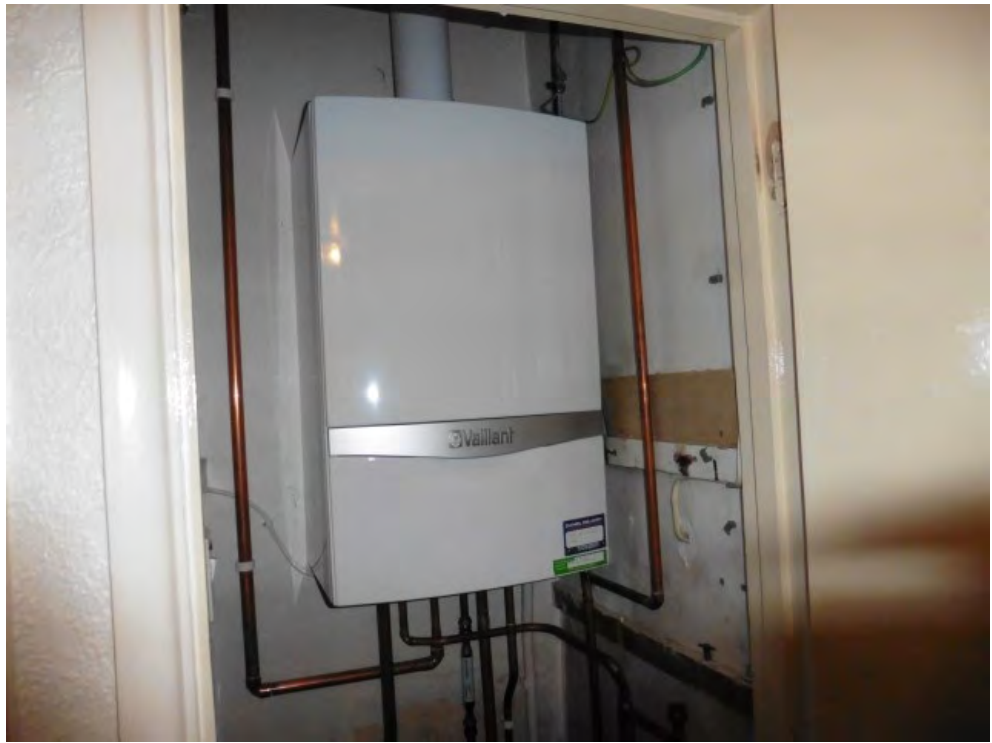
Boiler

Condition	<p>Documentary evidence was seen to indicate that the boiler was serviced in December 2015 and that checks confirm that the contractor is Gas Safe registered. The seller indicated that the boiler had been installed in 2009. This means that it is approximately eight years old and, therefore, around half way through its normal expected service life, subject to regular maintenance.</p> <p>At the time of the survey the heating was checked and the boiler</p>		
Action Required	<p>Gas Safe recommends that all gas appliances and boilers are inspected and serviced according to manufacturer's guidance, but at least once a year. A gas installation can look to be in a safe condition, but serious defects may be hidden, some of which can kill. It is therefore considered to be essential that you commission an inspection of the gas/heating installation prior to purchase of the property, unless you are provided with verifiable evidence that such an inspection has recently been carried out by a competent person.</p>

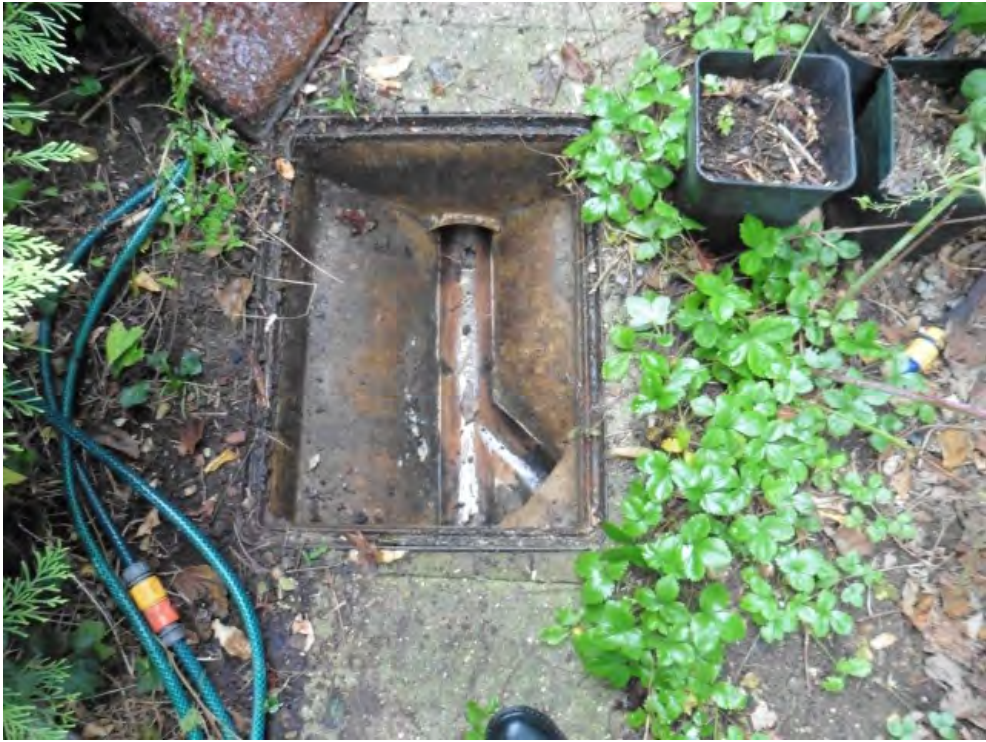
</div> <p style="text-align: center;">Inspection chamber to the rear</p>

Action Required	<p>Drains should be regularly inspected to ensure they remain free from blockages, tree root damage or other obstructions.</p>		
	<div style="text-align: center;">

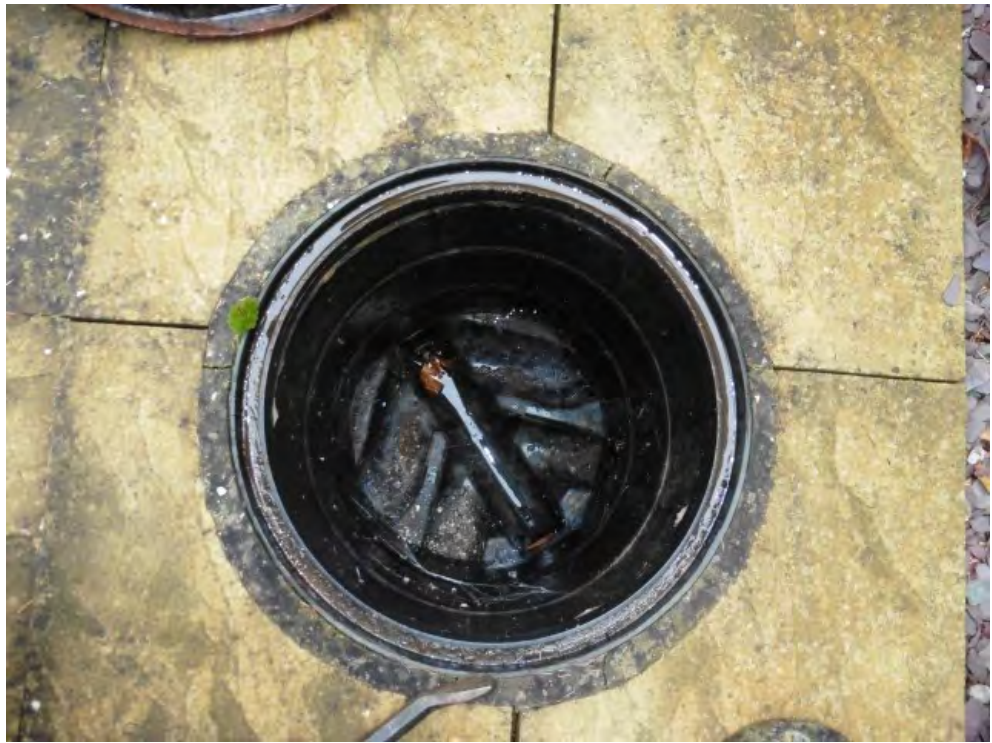
Inspection chamber to the front

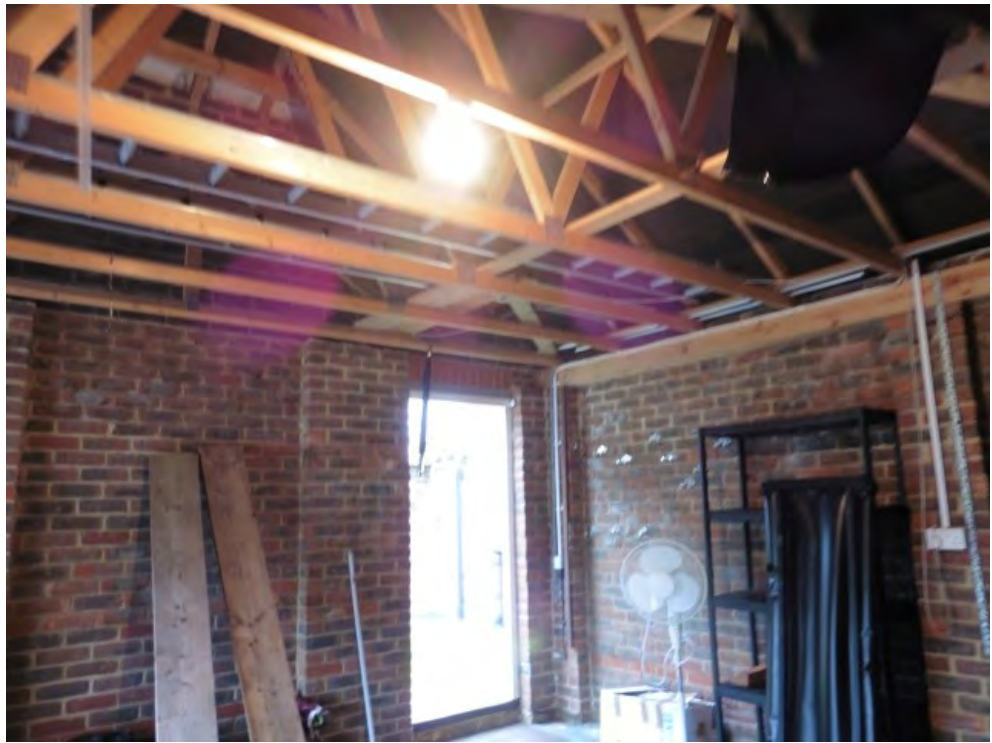
Garage internal review

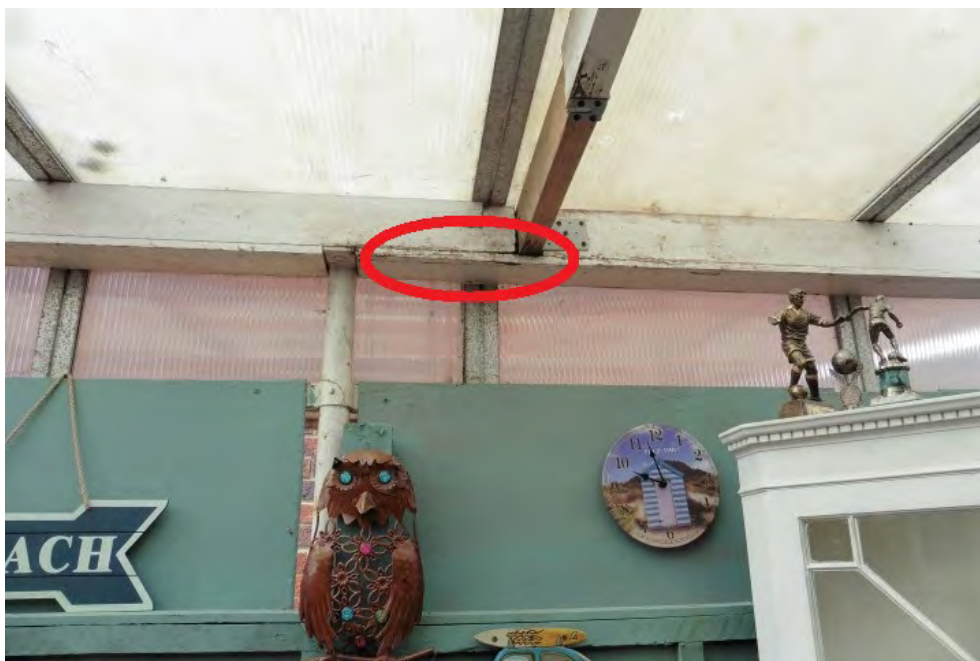
Possibly rotten timbers in the lean-to

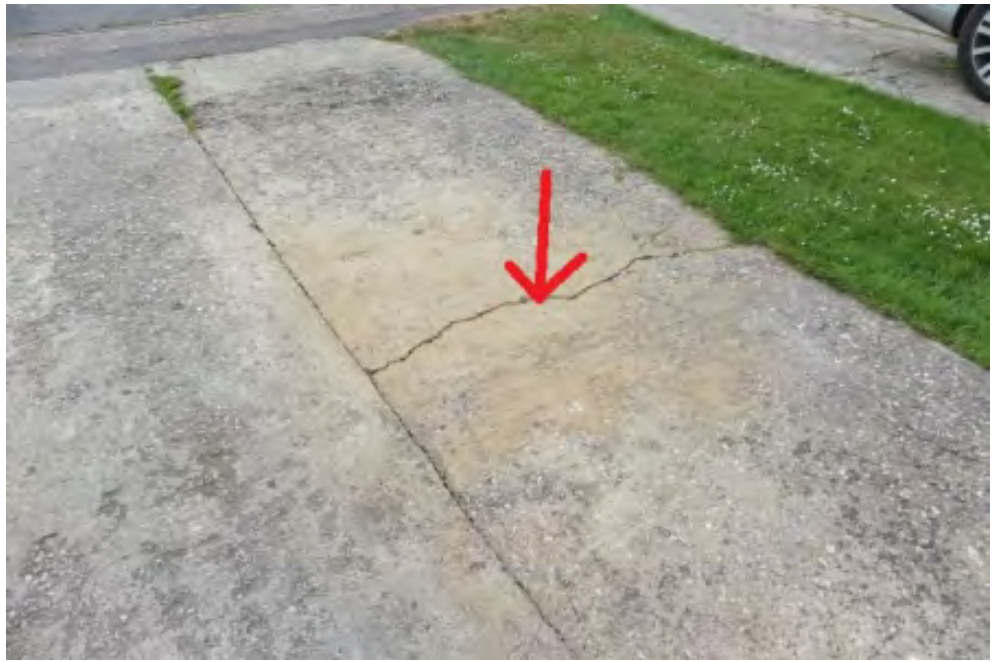
Cracking in the front drive

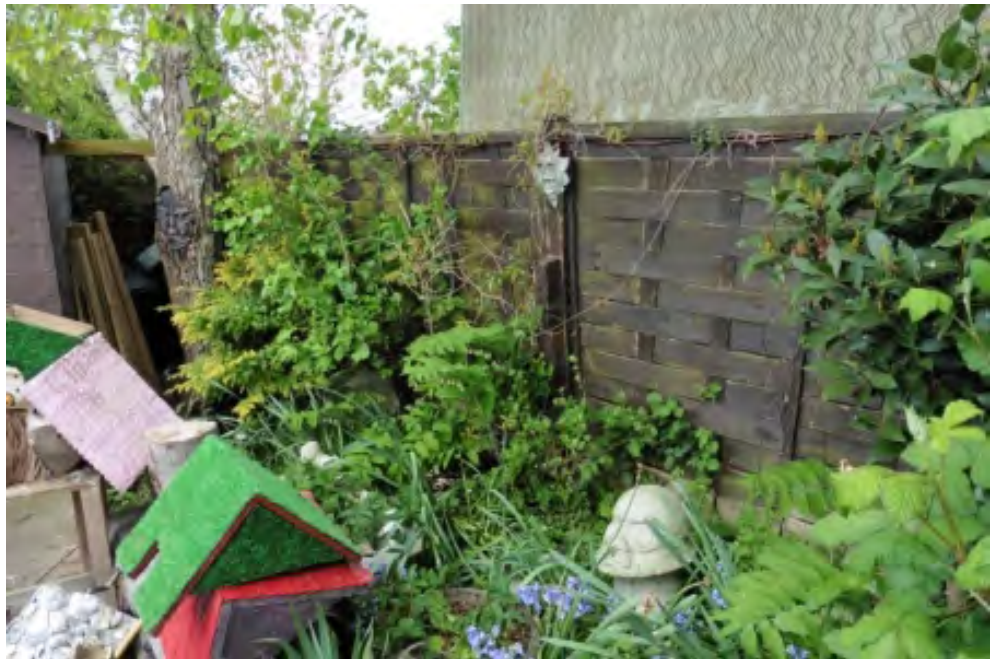
Rear boundary fencing maybe loose
