Home Condition Survey

17, Tickford Street
NEWPORT PAGNELL
MK6 5NA

Report Reference No: 5681909
Produced for: Mrs S Knight
Date: 27-Nov-2015
Surveyor: Mrs Carolyn Clay

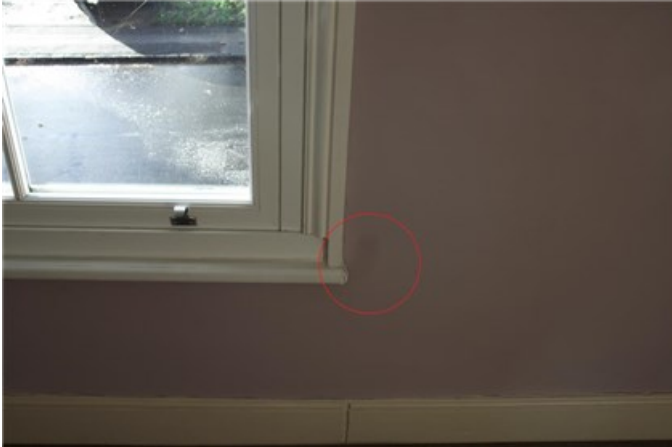
Penetrating dampness was found in the chimney breasts and areas of the external walls.

Bedroom 1 - damp by window

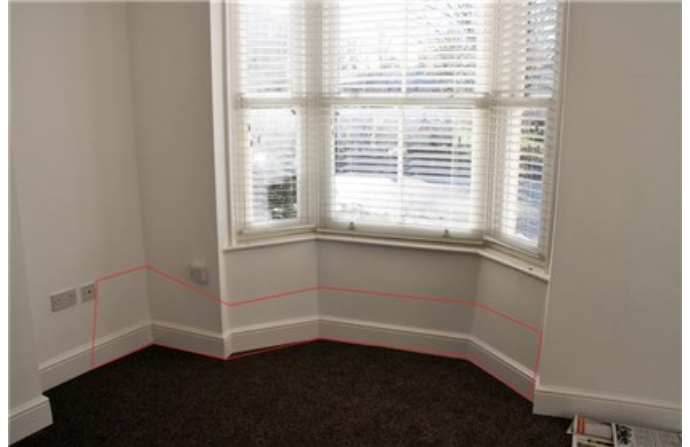
Lounge bay and party wall with rising damp

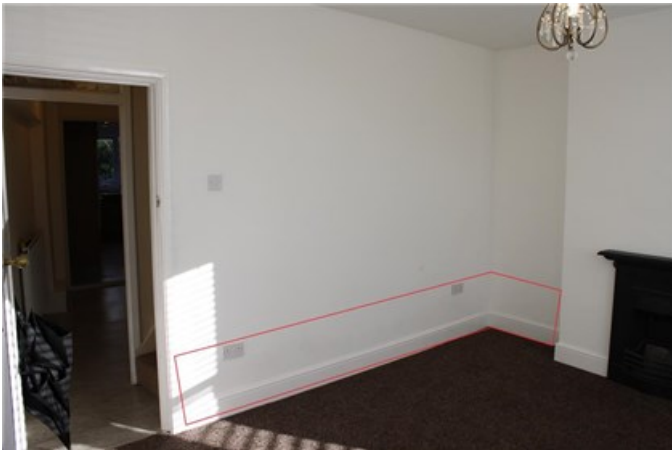
Lounge - rising damp to internal and party walls

<p>E3. Inside walls, partitions & plasterwork</p> <p>Party walls</p>	<p>Solid brick has been used to form the party walls (walls adjoining the neighbouring property). These have been plastered recently.</p> <p>High moisture readings were detected to the party walls at low level in most of the wall where readings could be taken. High readings to at this level indicate rising damp and a failure of the damp proof course.</p> <p>See Summary of Dampness. Further advice should be obtained from a damp specialist.</p>	3
--	--	----------

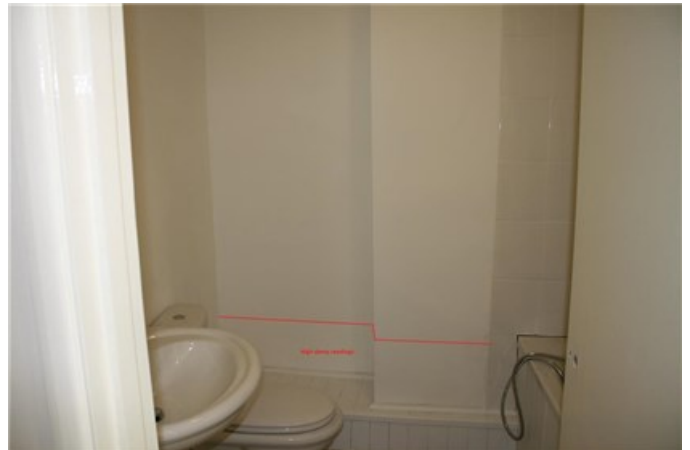
Bathroom - damp in the party wall and chimney breast

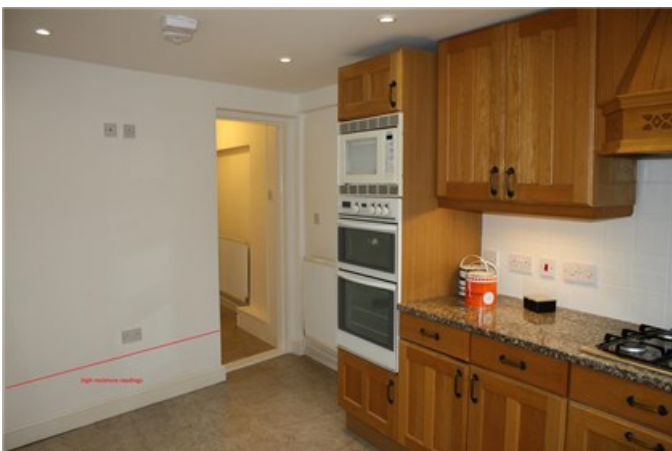
Kitchen - damp in original external wall

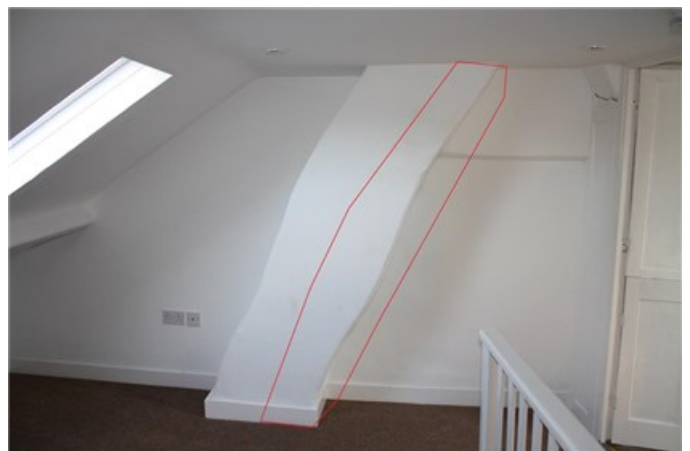
Rear 2nd floor bedroom - damp in chimney breast

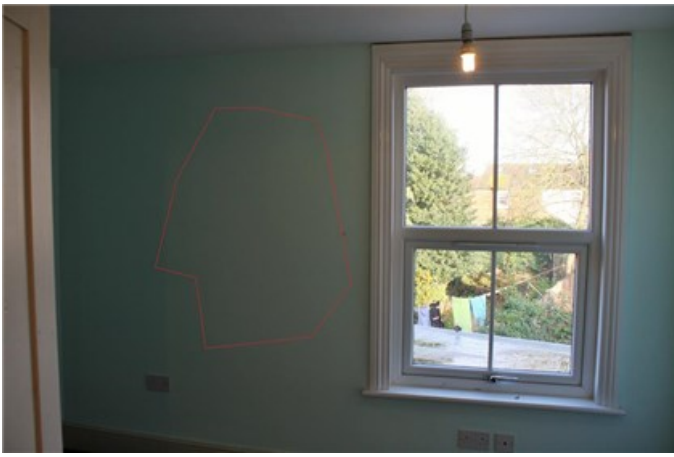
First floor rear wall - medium levels of damp detected

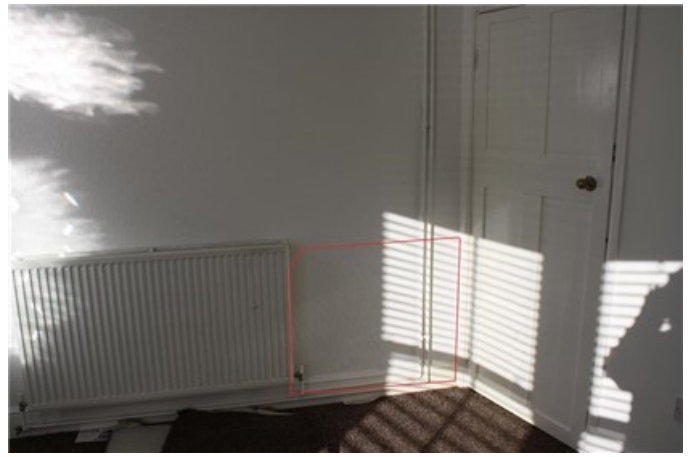
Lounge side wall - area of damp

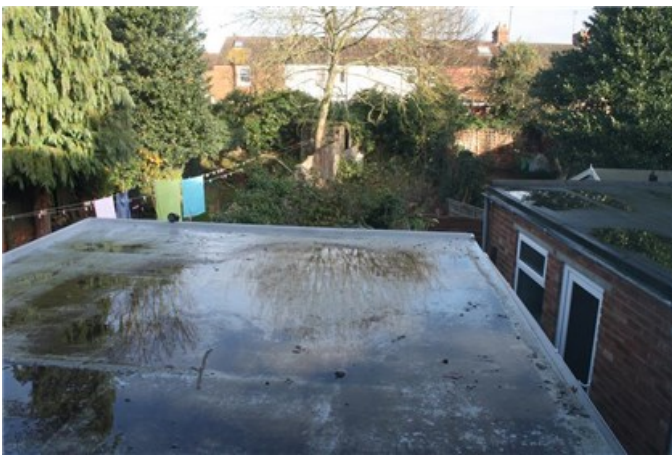
D2. Roof coverings Flat roof to kitchen	<p>The flat roof is covered with GRP. This has been replaced recently and guarantees should be requested.</p> <p>The flat roof covering has an inadequate slope. There should be a slight fall to allow rainwater to drain into the gutters. This is not occurring and rainwater was pooling on the roof.</p> <p>The roof replacement has not been finished at the left hand side. The edge has not been sealed and there is a gap which will allow the weather to penetrate between the roof finish and the ceiling causing penetrating damp.</p> <p>Although no damp was found during the inspection this is considered serious and in need of urgent repair.</p>	3
D2. Roof coverings Bay roof	<p>The bay roof is flat and covered with built-up mineral felt.</p> <p>This has been recently repainted and no defects were seen. However mineral felt has a limited life span and it is likely that this roof will need replacing in the near future.</p> <p>No repair is presently required. Normal maintenance must be undertaken.</p>	1

Flat roof to kitchen - rainwater is pooling

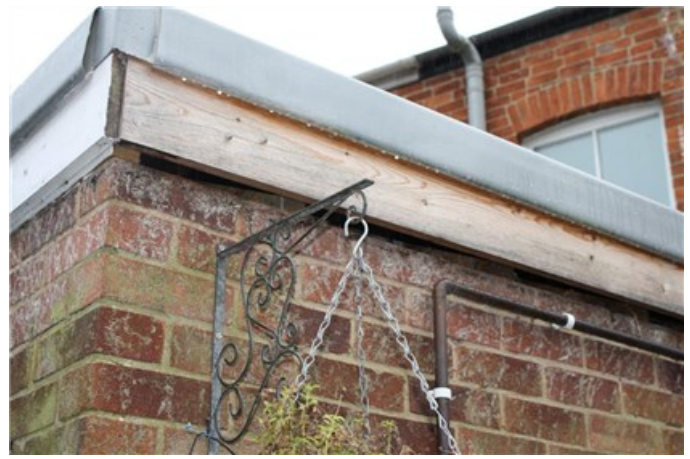
Flat roof - gap can be seen where edge isn't finished

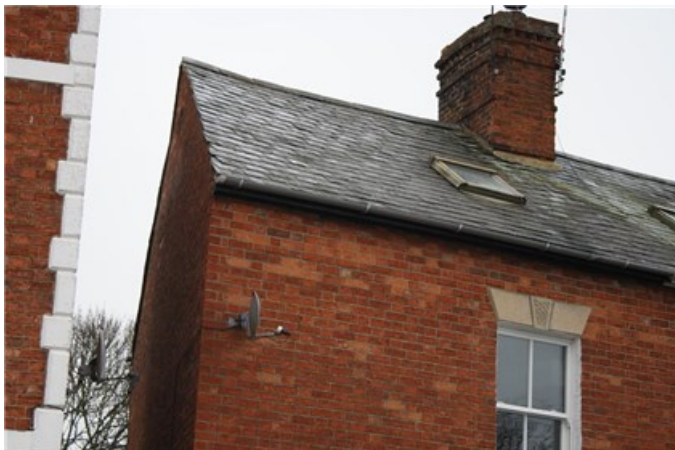
<p>D5. Main walls (including claddings)</p>	<p>The gable (side) wall is leaning out slightly at the top.</p> <p>The roof space was been converted into living space historically and the roof structure altered to allow these rooms. It is unlikely that this work was done under supervision of building control due to its age.</p>	<p>3</p>
<p>Gable wall</p>	<p>There is evidence that a new structural beam has been installed since 2013 to support the front pitch of the roof and hold the gable wall in.</p> <p>Further investigation is required regarding the actual works carried out and whether they are sufficient to stop any further movement. The works should be checked by a Structural Engineer.</p>

Gable wall - leaning out slightly at top

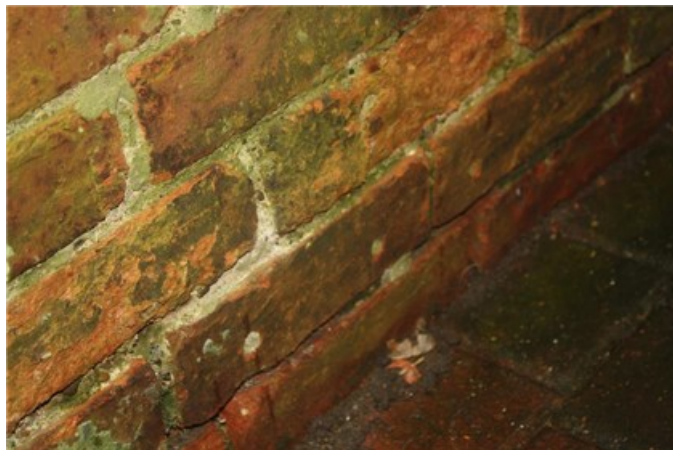
Side elevation wall - injected dpc

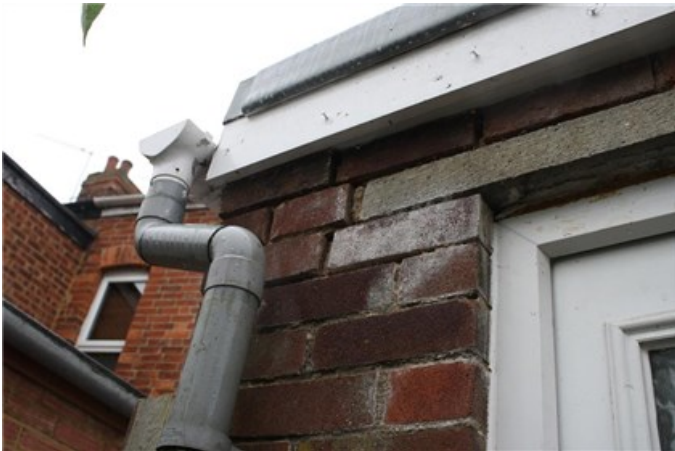
Kitchen rear wall - mortar missing

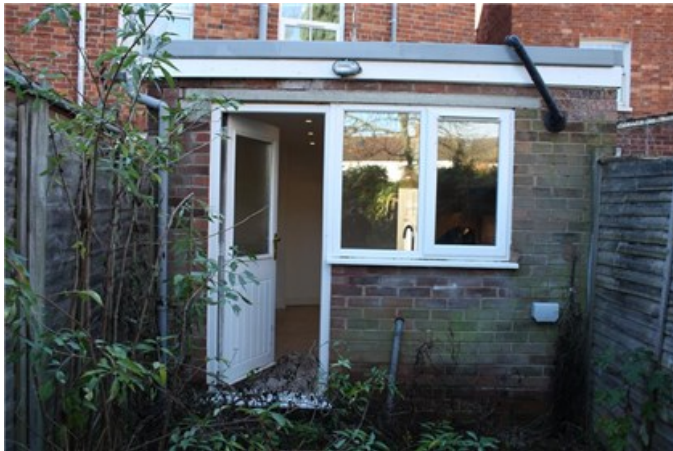
Rear wall - brickwork looks damp

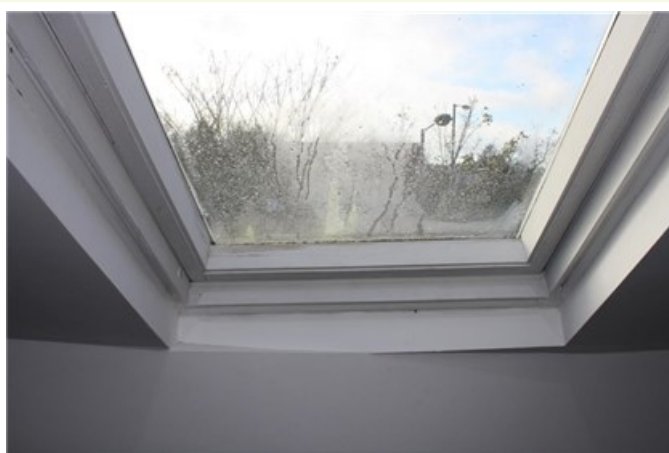
<p>D6. Windows</p> <p>Veluxes</p>	<p>The windows (veluxes) in the roof slopes are timber framed and are double glazed.</p> <p>The front velux appears to be crooked but this has been retrofitted between the roof timbers and the positioning would have been restricted.</p> <p>The sealed glazing unit to the front velux has failed causing misting. It is also very stiff and I couldn't open it properly. This should be investigated further.</p> <p>Due to the position of the roof windows it would not be possible to exit the second floor in the case of fire. This is a serious health and safety risk, see Section C.</p>	<p>3</p>
--	---	----------

Front velux - misting in unit

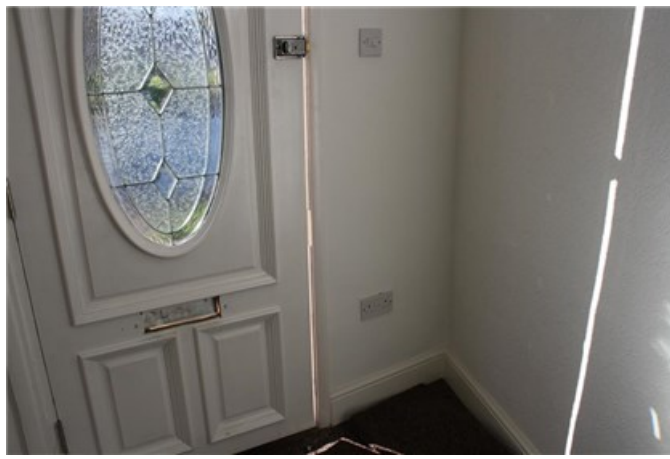
<p>D7. Outside doors (incl. patio doors)</p> <p>Front door</p>	<p>The front door is formed in hardwood with a decorative sealed double glazed unit and set in a hardwood surround.</p> <p>The operation of the doors and their locking mechanisms is satisfactorily, however, as you will be unaware of who may hold keys to the property, it would be a sensible idea to change the external locks.</p> <p>The door has swollen in its frame and is very difficult to open from the inside. This should be repaired before anyone moves into the property for safety reasons.</p>	<p>3</p>
--	---	----------

Front door will not close without force

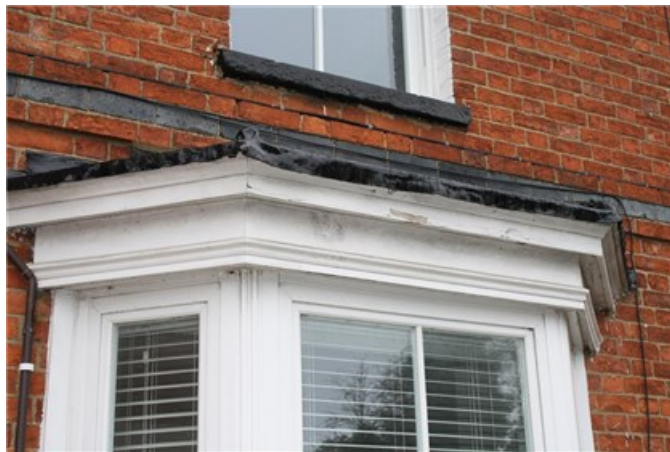
Top of bay window

<p>D8. Other external woodwork etc</p>	<p>Fascias [facing boards to which the gutters are attached], and the bargeboards [timbers which edge the gable of the roof] appear to be the original softwood timber.</p> <p>The top of the bay window is also timber.</p> <p>There was no evidence of significant rot to any parts from the ground but it is likely that the tops of the fascia boards are rotting due to age.</p>	<p>2</p>
<p>D9. Outside decoration</p>	<p>All external timbers are painted and so is the front stone window cill and bay roof.</p> <p>Some of the paintwork is flaking and requires renewing.</p> <p>Although this is not considered serious or urgent the timber should be repainted to protect the timbers from rot.</p>	<p>2</p>

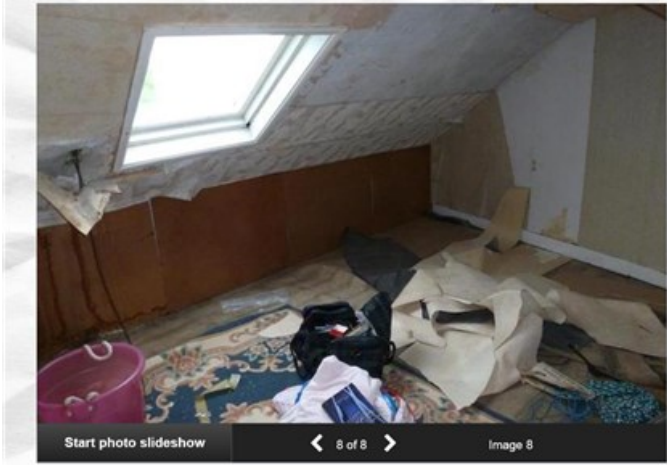
Historic photo of front roof room - no beam

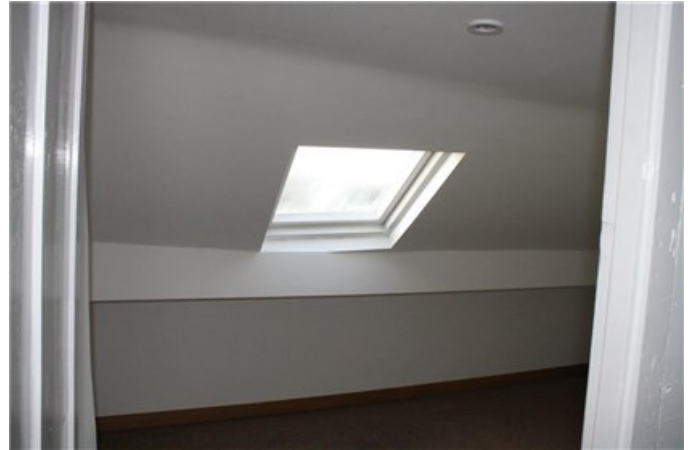
Photo of front roof room - new beam

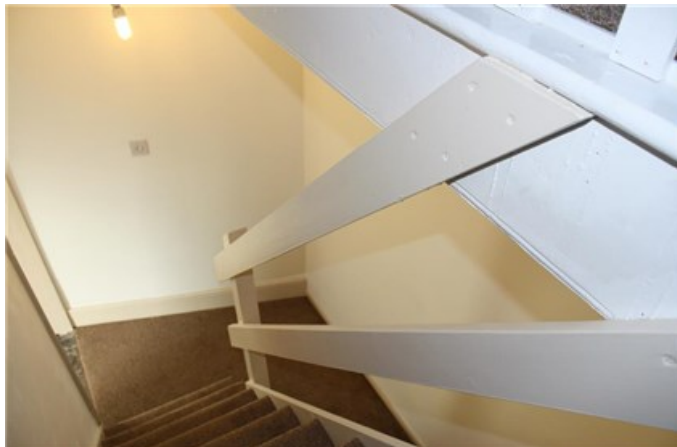
Stairs to 2nd floor - gap is too wide

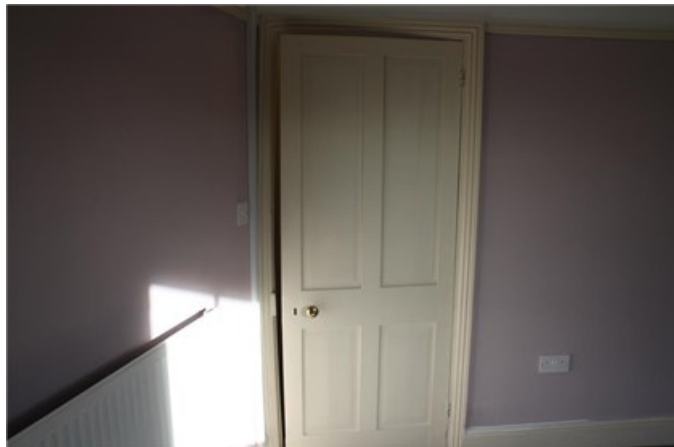
Front bedroom door - too small for frame

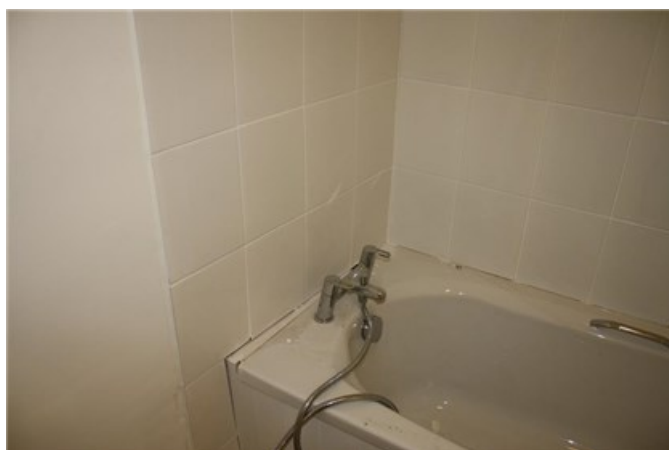
<p>E8. Bathroom fittings</p>	<p>The bathroom contains a bath, basin and WC. They are replacements for the original suite.</p> <p>Sealant is inserted along the edges of the fittings to prevent water flowing behind the units resulting in rot and must be carefully maintained.</p> <p>The sealant is missing around the bath and this should be finished before the bath is used to stop water getting underneath.</p> <p>The WC base has been sealed with mastic to the floor but it has not been bolted down. This is required to stop the WC moving over time.</p>	<p>2</p>
---	---	----------

Sealant missing around bath

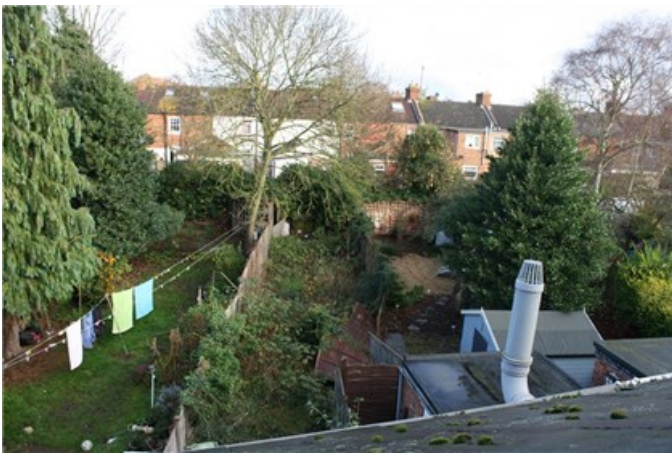
Rear garden

Grounds	The grounds are overgrown with brambles and weeds.
----------------	--

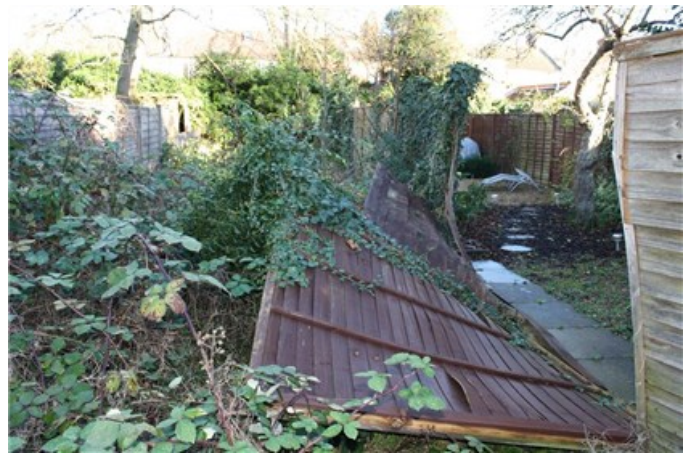
Rear garden - fence collapsed
