BUILDING SURVEY REPORT

PROPERTY Sample Survey
Anytown
AA11 1AA

SURVEY DATE 2 Jan 2018

REF 12345

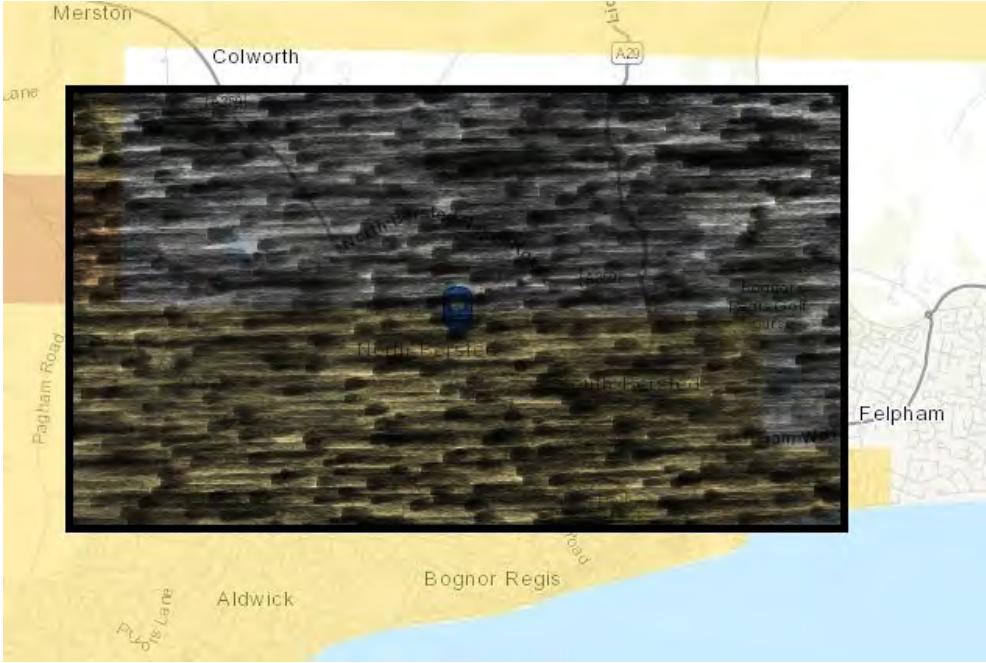
Geology	The property is located in an area where the ground is based on chalk. However, properties in this area are not normally affected by seasonal movement of the ground.
Radon	<p>It is understood that the property is in a postcode area that may be affected by high levels of naturally occurring Radon Gas emitted from the ground.</p>

<p>Radon medium risk</p>

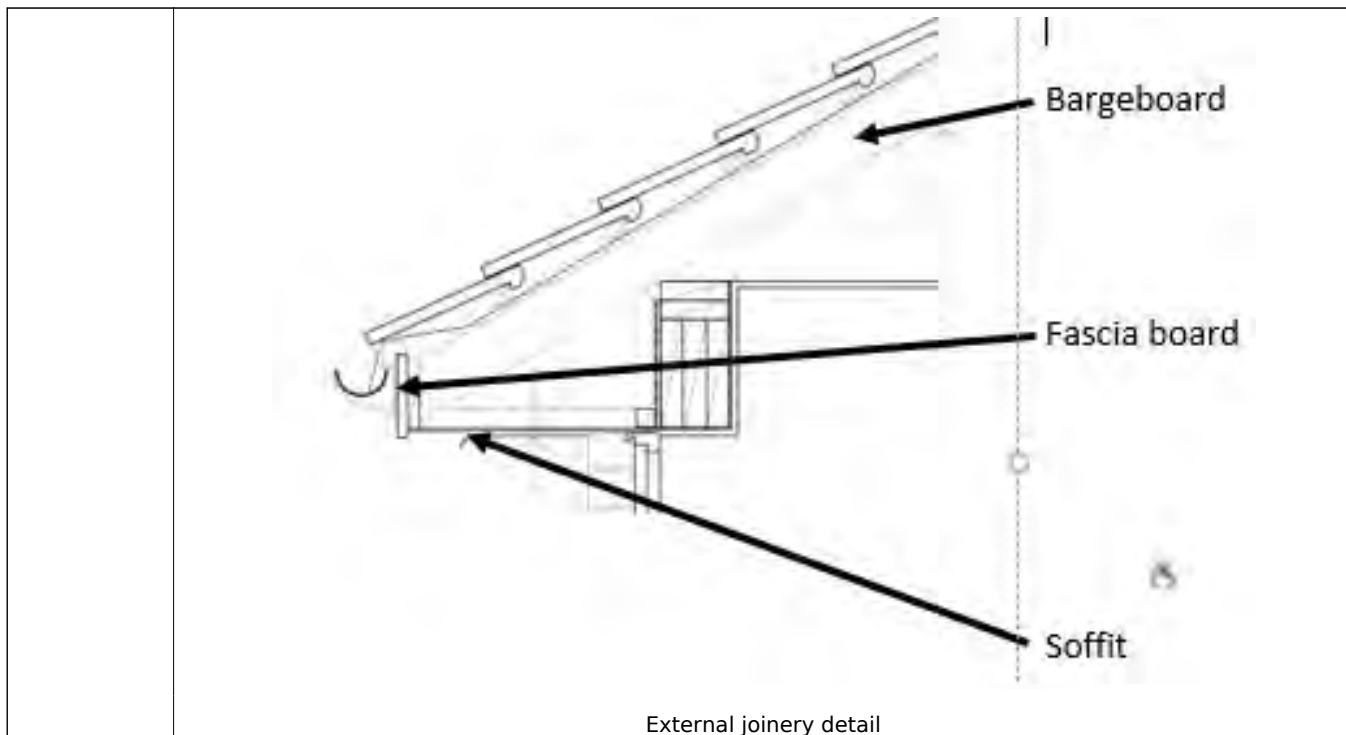
<p style="margin-top: 10px;">Rot in the fascia at the front</p> </div>

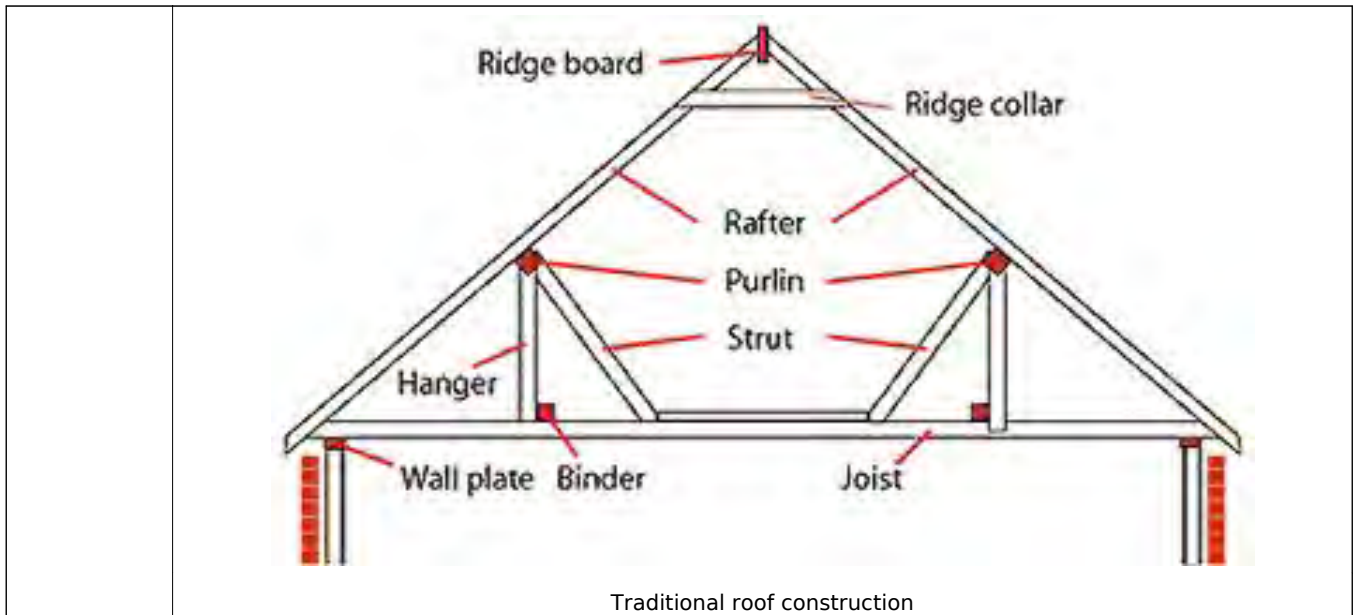
Normal moisture reading in roof timber
