Home Condition Survey

17, Tickford Street
NEWPORT PAGNELL
MK6 5NA

Report Reference No: 5681909
Produced for: Mrs S Knight
Date: 27-Nov-2015
Surveyor: Mrs Carolyn Clay

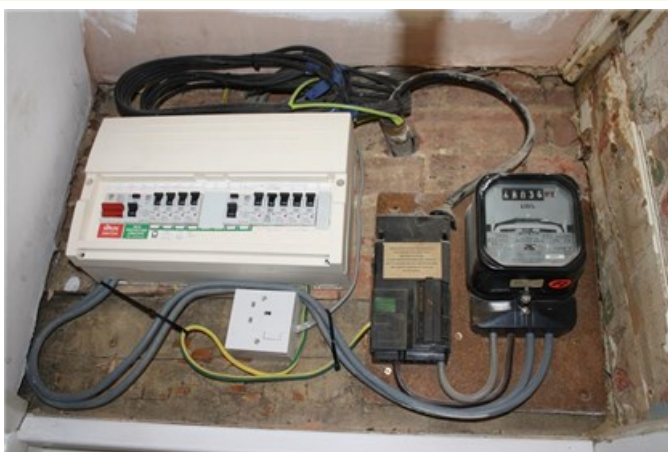
<p>F1. Electricity</p>	<p>The property is connected to the main electricity supply and the meter is located at the base of the stairs, at high level.</p> <p>The consumer unit [fuse box] is a modern RCD unit which has been fitted in the last few years.</p> <p>Power sockets are provided on a ring main and lighting is provided to every room.</p> <p>I believe that the electricians have been replaced recently and therefore a Part P certificate should be available.</p> <p>However, I did not see a test certificate and the absence of such a test certificate is a hazard [see Section C] and necessitates the imposition of a Condition 3 Rating.</p>	<p>3</p>
-------------------------------	---	-----------------

Electric meter and consumer unit
